BA-2075  
Joshua Hynes House  
318 Oella Avenue  
Oella vic.  
Private  
c. 1849-51

## Maryland Inventory of Historic Properties Form

historic Joshua Hynes House

Name Joshua Hynes House  
Continuation Sheet

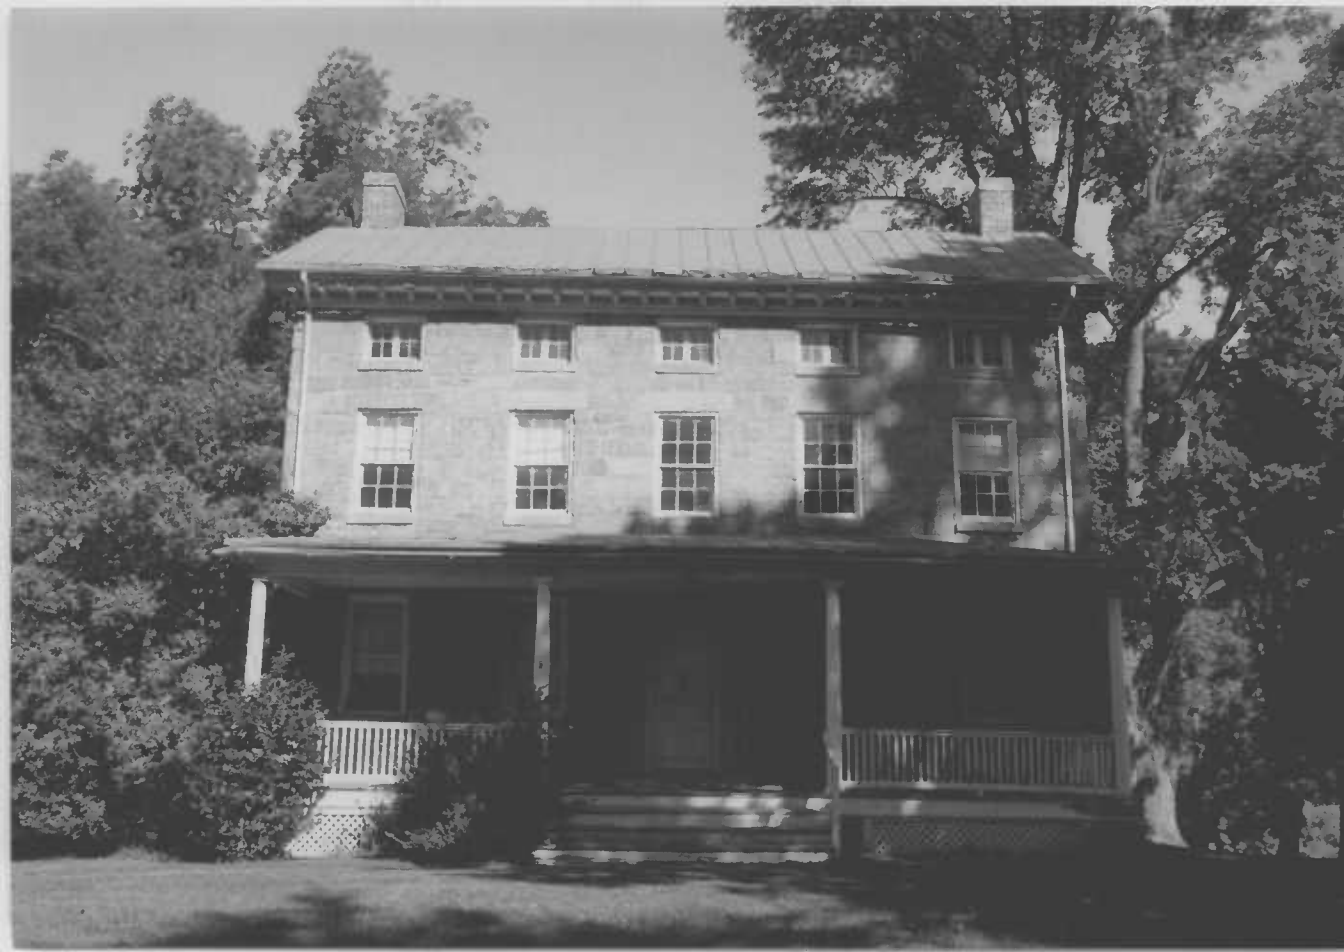
1/6

Southeast + EU

The southeast elevation has a center entrance with a granite sill that has a wash and a granite lintel. The six-panel door has the frieze panels in the center, and has sunken fields and quirked ogee and bevel panel moulds. On either side of the door are posts with a bead on each side. There are sidelights with three lights over one panel, and the panels are sunk and flat, with quirked ogee and bevel moulds. The doorframe is mitered and has a beaded interior edge. The transom bar has an ogee at the top and a bead at the bottom. There is a three-light transom that is flanked by scrolled brackets and one light over each sidelight. There are two six-over-six sash on each side of the doorway, and the frames are the same as the door frame. They have a granite sill and lintel, and the sill has a chiseled finish. The top sash is fixed, with a stop beneath it. There is shutter hardware, too. Some of the stone has drill holes, and it has a quarry face texture. The mortar is cream-colored, but the surface is gray and it is not clear whether this is a dirt layer or a pigment to blend the mortar in with the stone. On top of this gray layer there is penciling that varies from 1/8-inch to 3/16-inch wide. There is a one-story, five-bay porch with four granite piers supporting it, a wood deck, four wood Doric columns with square balusters between them, a beaded-edge board soffit, and a hip roof of standing seam metal. The second story has five six-over-six sash that match the first story. The third story has five frieze windows, each with a pair of four-light casements and typical sills, lintels, and frames. There is a modillion cornice with returns.

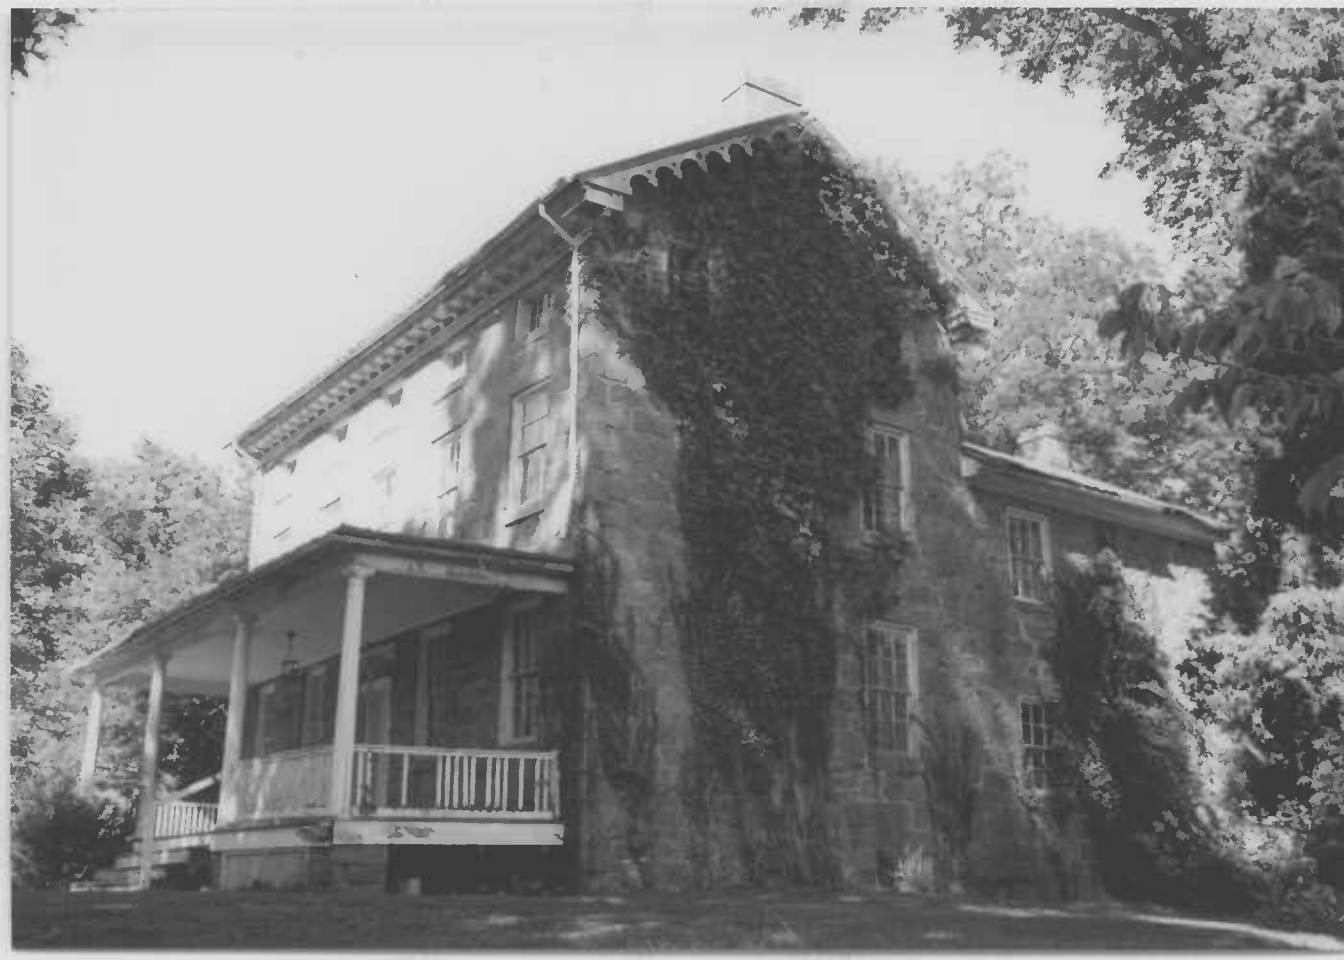
2/6

Southwest & northeast elevs

The northeast elevation foundation has a boarded-up window opening in a plain frame in the north bay. This opening has a granite sill and lintel. The first and second stories have a typical six-over-six sash in the north bay. The third story has a pair of two-light casements with blinds in both the north and east bays, and these windows extend into the gable end. There are jig-sawn bargeboards in the pattern of three-lobed cusps on the gable end. The northeast elevation of the ell has no openings in the foundation. The first and second stories have a typical six-over-six sash in the east bay, and there is a wood box cornice.

The southwest elevation of the main block has a cellar bulkhead with stone cheek walls in the west bay of the foundation, but the door is gone. There is a narrow beaded-edge vertical-board door set in the wall. Above each cheek wall are two holes drilled into

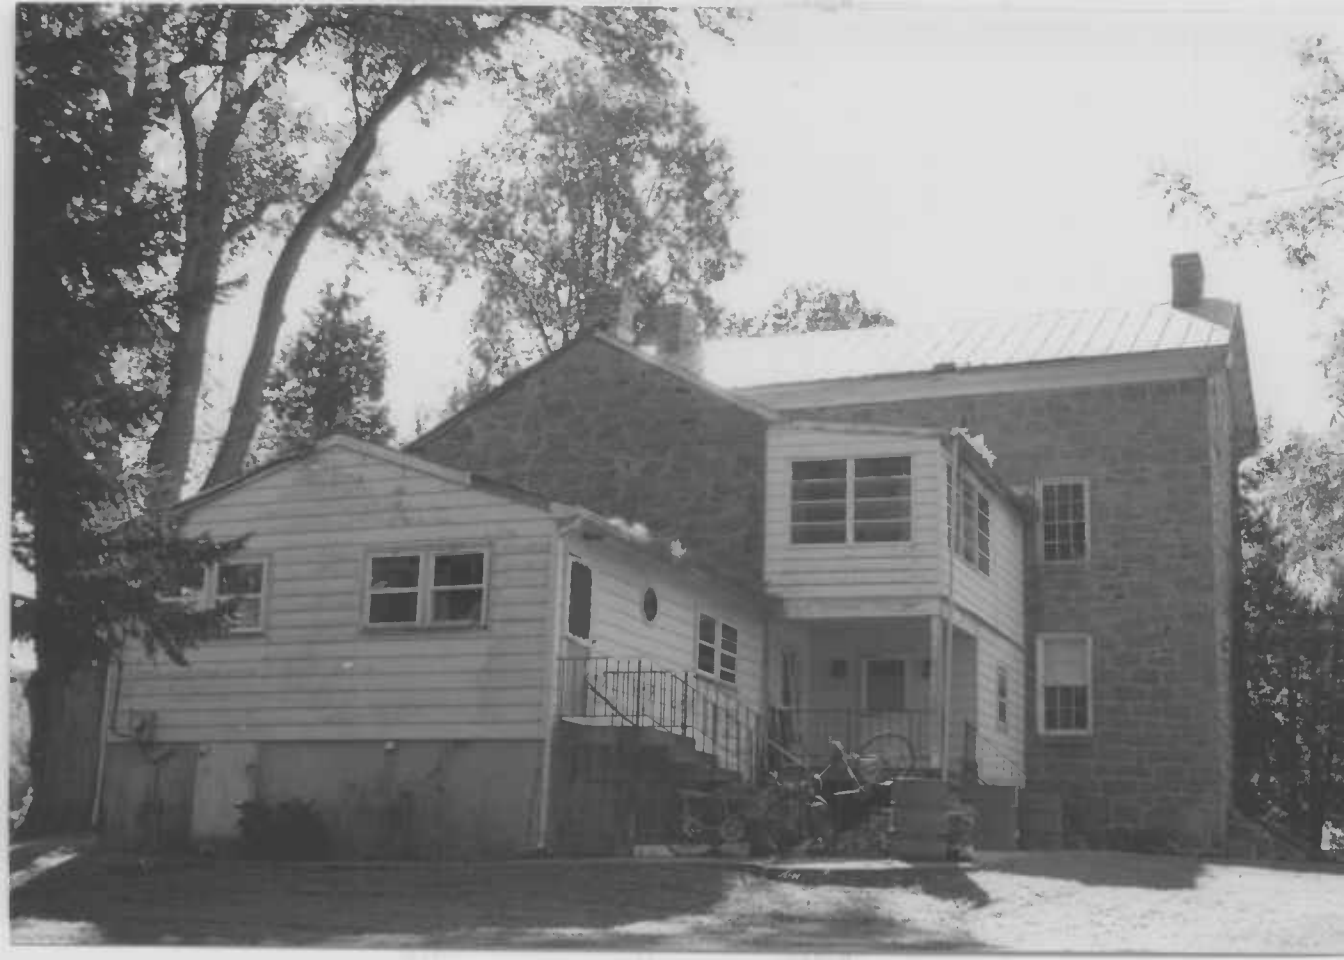
3/6

Northwest eleu

The northwest elevation of the main block is three bays, with the north bay covered by the ell and the center bay covered by the enclosed porch. The foundation is a darker rubble stone that is probably gneiss. The first and second stories have a typical six-over-six sash in the west bay and the third story has no openings. There is a wood box cornice with one modillion on each side of each corner. The porch is enclosed with aluminum siding and has mid- to late-20th century windows.

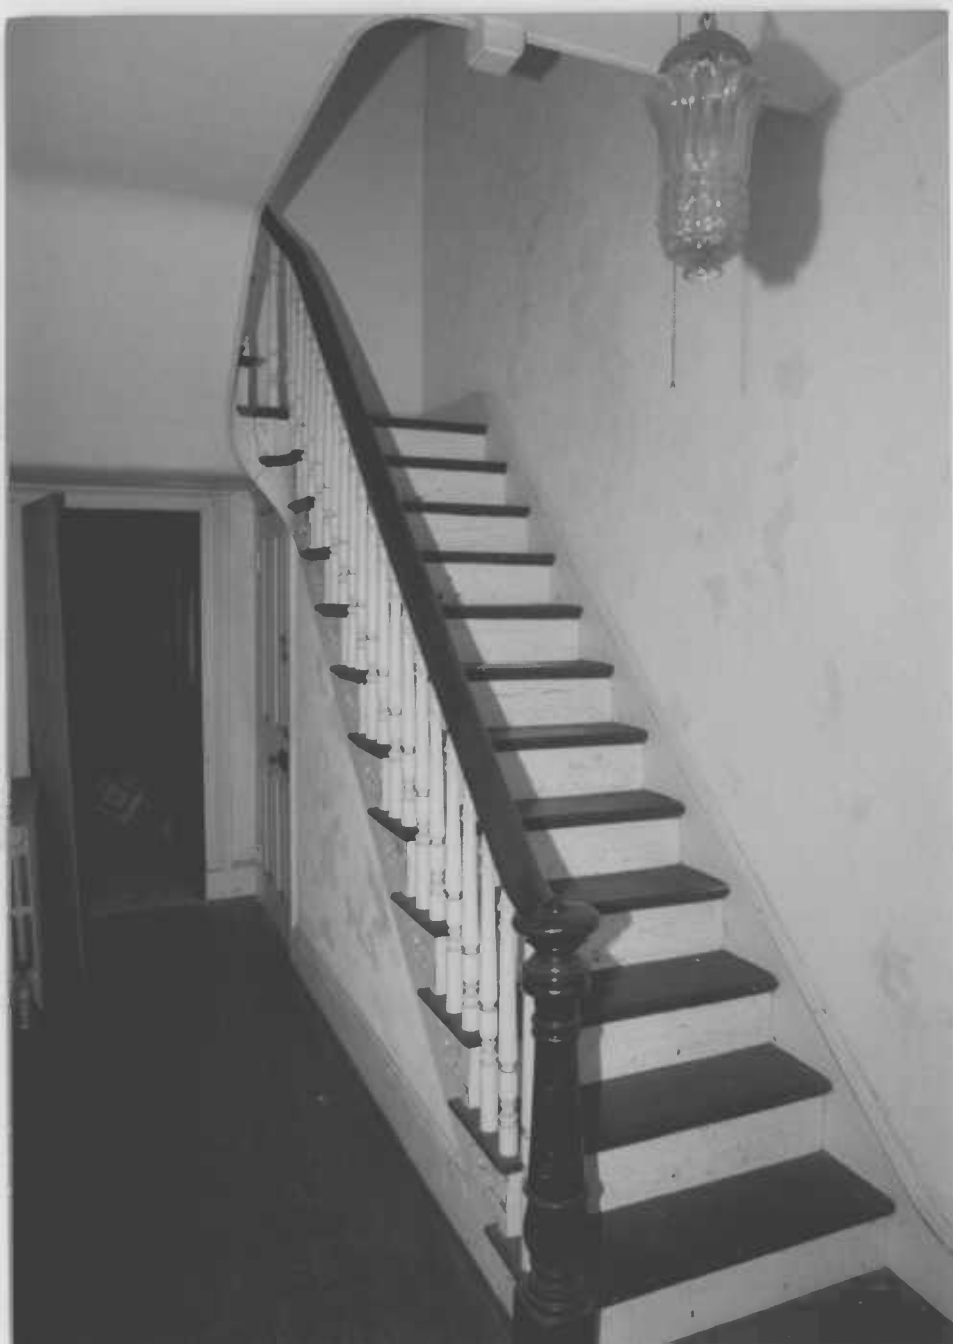
4/6

stairs-1<sup>st</sup> sty.

The house has a center-passage, single-pile plan with one room in the ell and an enclosed porch on the rear, plus a new wing on the back of the ell. The passage has a two-run stairway that ascends to the northwest on the northeast wall. It has an open stringer with sawn scroll brackets, turned balusters and newel, and an ovoid handrail. The newel post and handrail are natural finish and appear to be walnut. Beneath the stairs are a plaster wall and a door leading to the cellar stairs. This door has four panels with sunken fields and quirked ogee and bevel panel moulds. It has cast iron butt hinges with five knuckles and fast joints, and they appear to be plain. There is a plain cast iron rim lock with a brass knob, and it appears to be original. The first-story stairs have the bottom riser nailed to the end of the tread with a cut nail. The top of the riser is notched in order to screw the riser into the bottom of the tread above. The floor is covered with tile, the baseboard has an ogee and bevel, and the architrave has a quirked ogee and bevel back band and a beaded interior edge. The southeast, or front, door has six panels, with the small frieze panels set in the center. They have sunk fields with quirked ogee and bevel panel moulds. There is a cast iron rim lock labeled with "RECO" inside a diamond, and it has decorative brass knobs with geometric foliate decoration. This lock is not the original to the door, as there was a slightly larger lock once. The door is hung on cast iron butt hinges with five knuckles and fast joints. They appear to be plain, and are typical for the house. There is a three-light transom, and a one-light transom over each sidelight. There is one panel beneath each sidelight, and it is sunk and flat, with a quirked ogee and bevel. The northeast door has four panels with sunken fields and quirked ogee and bevel panel moulds, which is typical for the house. It is hung on new hinges and has a plain cast iron rim lock with a brass knob, which appears to be original. The northwest, or rear, door is gone and the jambs have been paneled. The ceiling of the stair landing has sash-sawn lath with cut nails. The joist here is also sash sawn, and is 3 inches by 8 ½ inches. The door to the southwest room is missing.

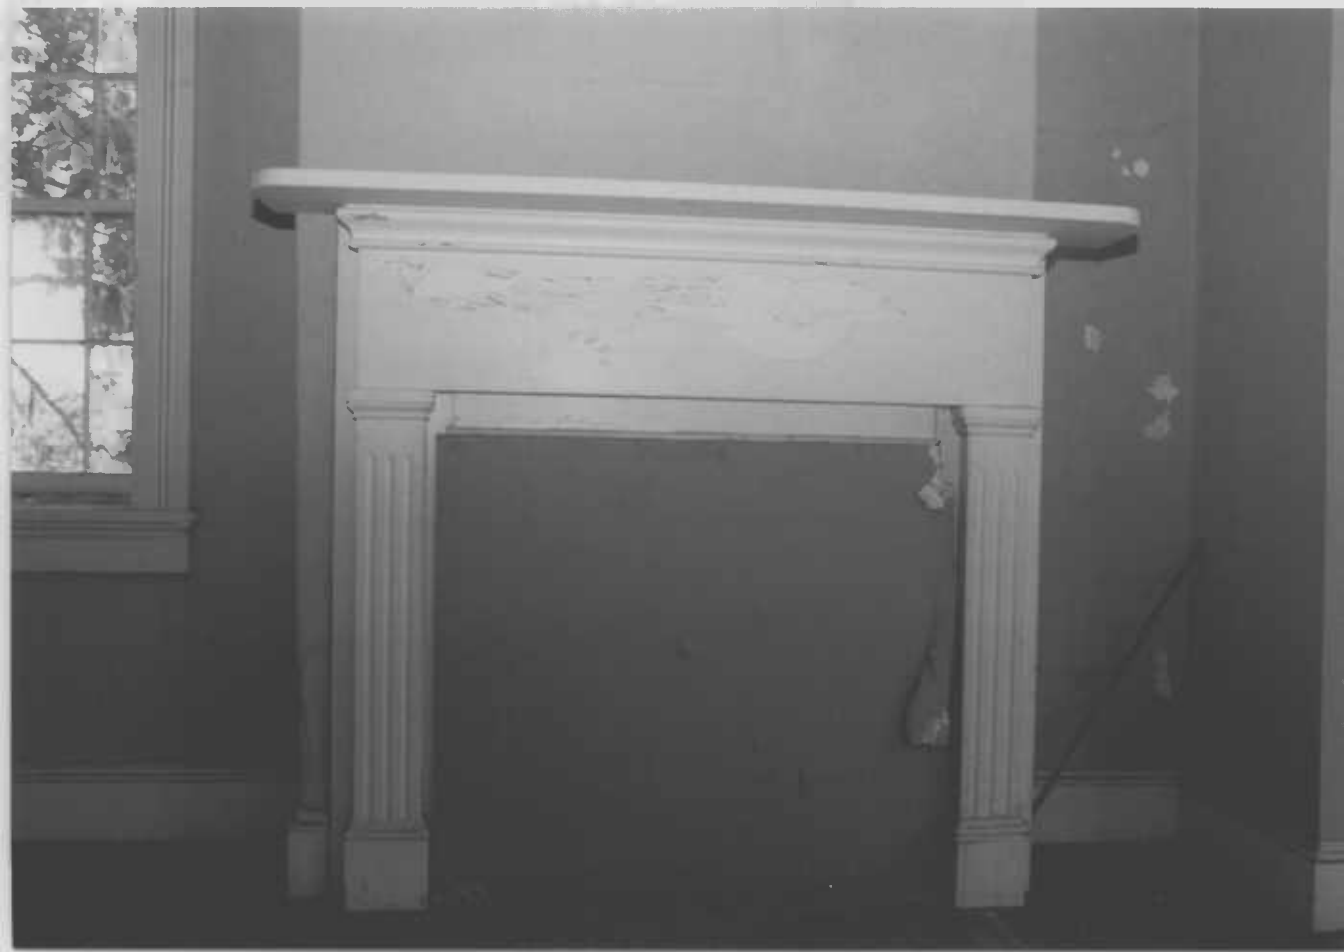
5/6

Northeast chamber mantel

The northeast chamber baseboard and architrave match that of the second-story passage, as does the quirked ogee and bevel beneath the windowsills. The sash is typical. The southeast wall is studded out with studs that are about 2 ½ inches deep and about 2 ¼ inches wide. The studs are then furred out with a piece of lath, at least in some instances, and there is both sash sawn and circular sawn lath fastened with cut nails and plastered. The stone has no traces of any finish material, suggesting that the stud wall is original. The northwest wall also sounds hollow. The fireplace on the northeast elevation has a brick hearth that is too small for the existing mantel. The fireplace has splayed brick jambs that start to corbel in below the bottom of the mantel, and the jambs are partially chipped away. The wood mantel is similar to that in the northeast room, but the pilasters only have three flutes. The mantel is face-nailed with wire nails and appears to have been moved to this location, possibly from the southwest room. On the northwest elevation is a four-panel door set to the north that leads to the ell passage. The door has sunk fields with no panel moulds, has typical architrave and lock and hinges, and has mineral knobs. There are three steps down to the ell passage.

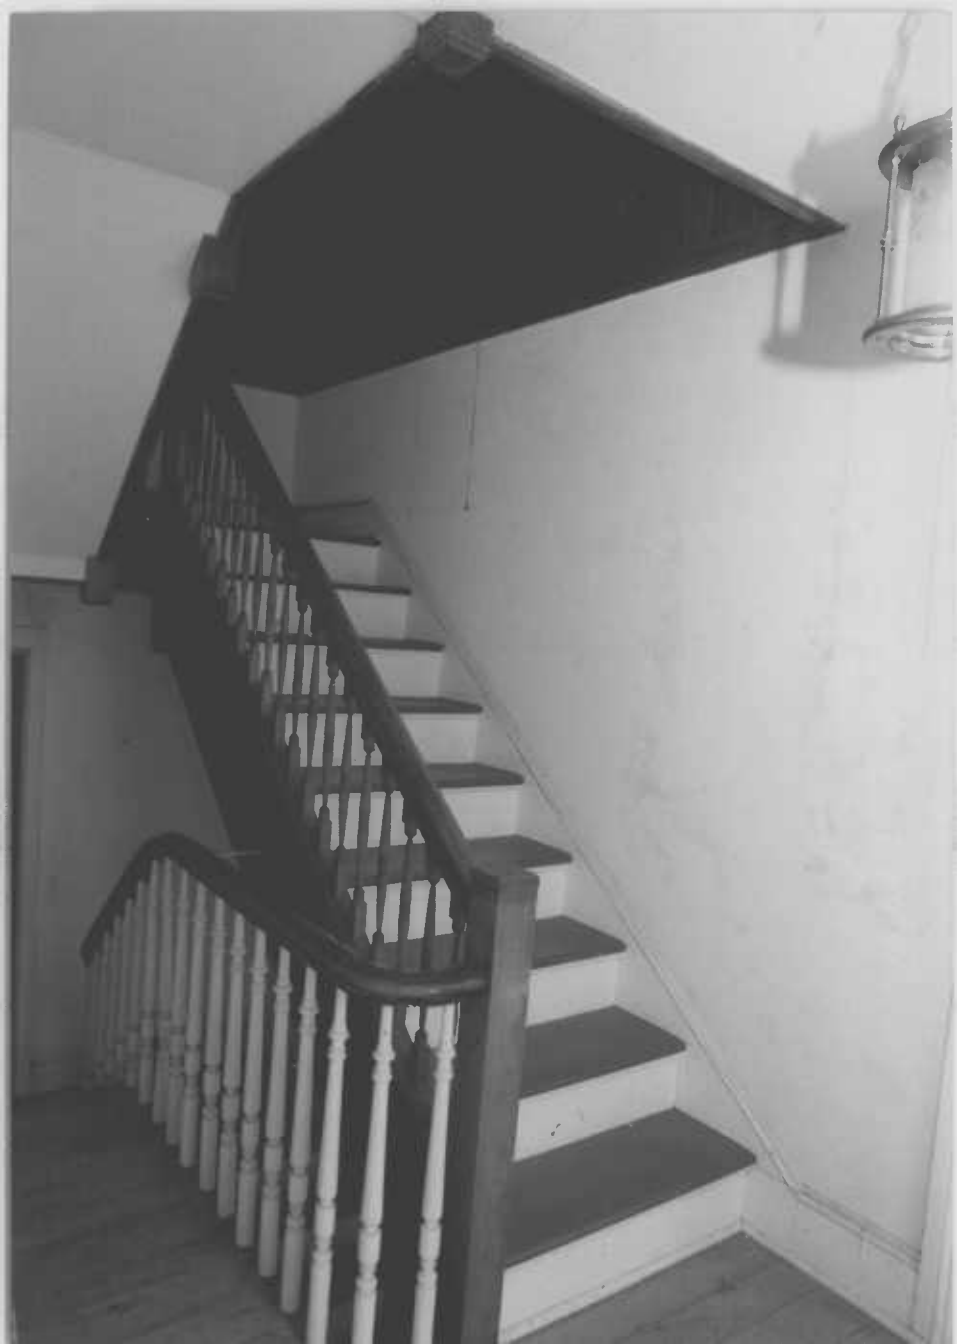
6/6

Stairs - 2<sup>nd</sup> sty

The second story has a center passage with one chamber to the northeast, two to the southwest, and a side passage along the northeast in the ell, with two chambers to the southwest side. The porch is also enclosed on the second story, and connects to the main block at the stair landing on the northwest end of the passage. There is a doorway here with head cut trim and a beaded interior edge, and the jambs are covered with modern paneling. The second-story passage floor is random width pine between 3 ½ inches and 4 ½ inches wide and it runs northeast-southwest. The rest of the flooring in the main block matches this. The baseboard, architrave, doors, hinges, and locks are the same as the first-story passage, but most locks have mineral knobs. The two doors on the southwest have porcelain knobs on the passage side only. On the southeast elevation is a window with straight plain wood jambs, 10-inch by 14-inch lights, and no parting beads. The stairway continues up to the third story, but has a plain, square oak newel post, turned oak balusters, and a moulded oak handrail. The stair has a closed stringer of pine with chatter marks.
